Innovative Housing Grants Program

SUMP PUMP STUDY

OCTOBER 1991

CH2M Hill Engineering Ltd.

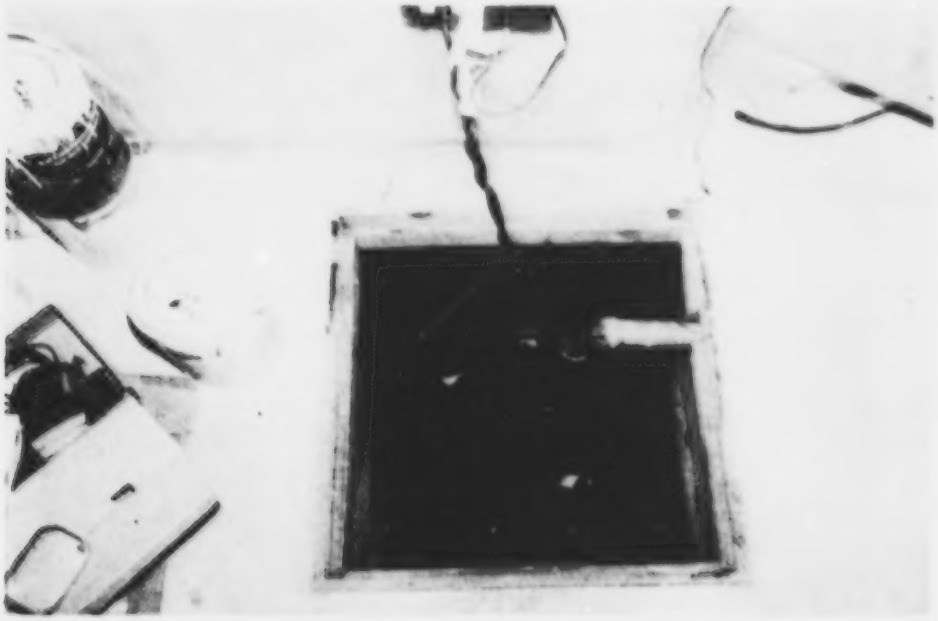
Photo 2 - Two Pump System This is a sump pump system with two pumps. The pump at the lower right acts as a backup. This homeowner experienced basement flooding with the original single sump pump.

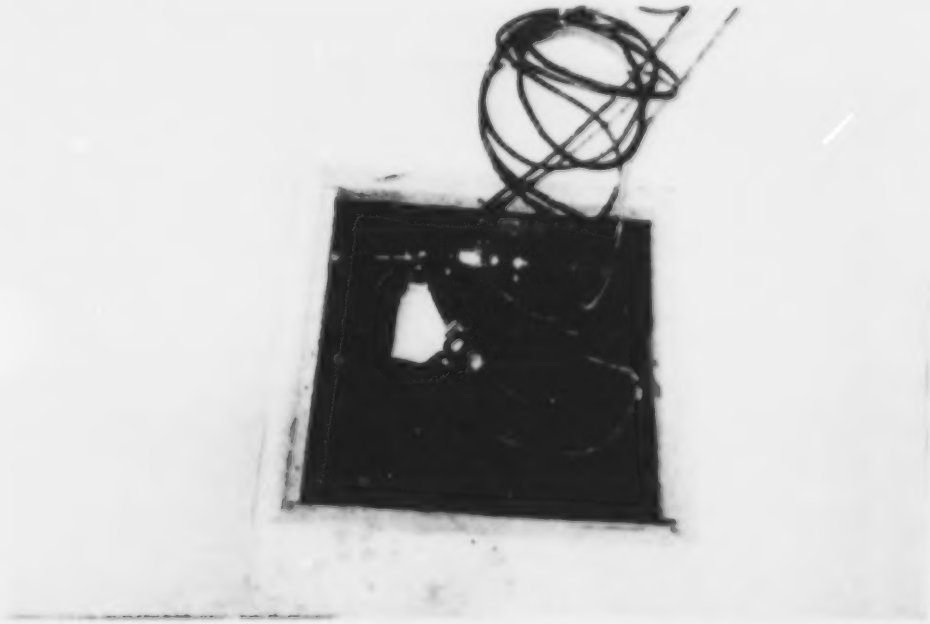
Photo 3 - Dry Sump Pit This sump pump system was dry and has only run a few times in a 2-year period. The pipe in the lower right corner is either a vent and/or overflow.

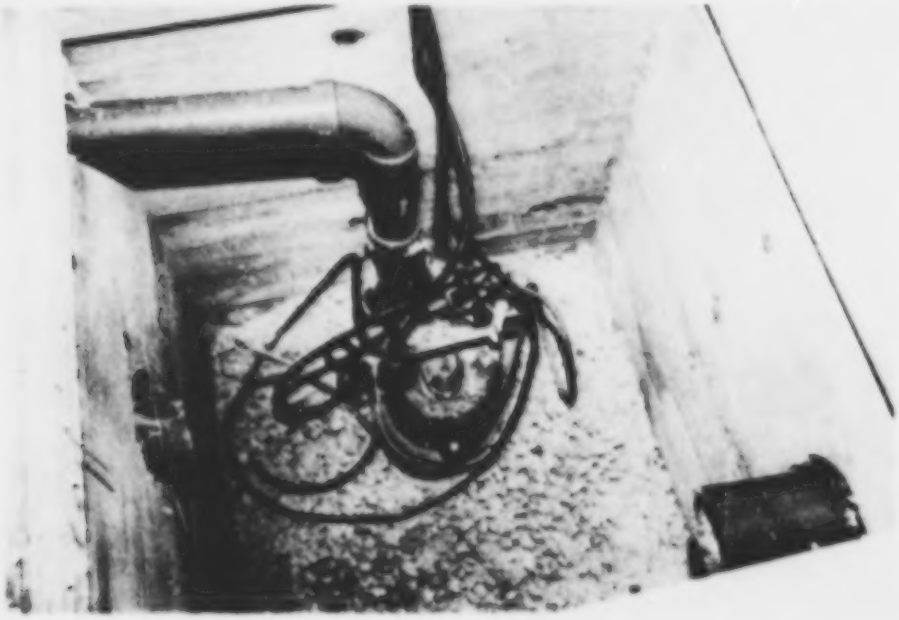
Photo 4 - Discharge Hose The homeowner has attached a flexible hose on the pump discharge to vary the location of discharge water to minimize ice buildup of this extremely active sump pump system.

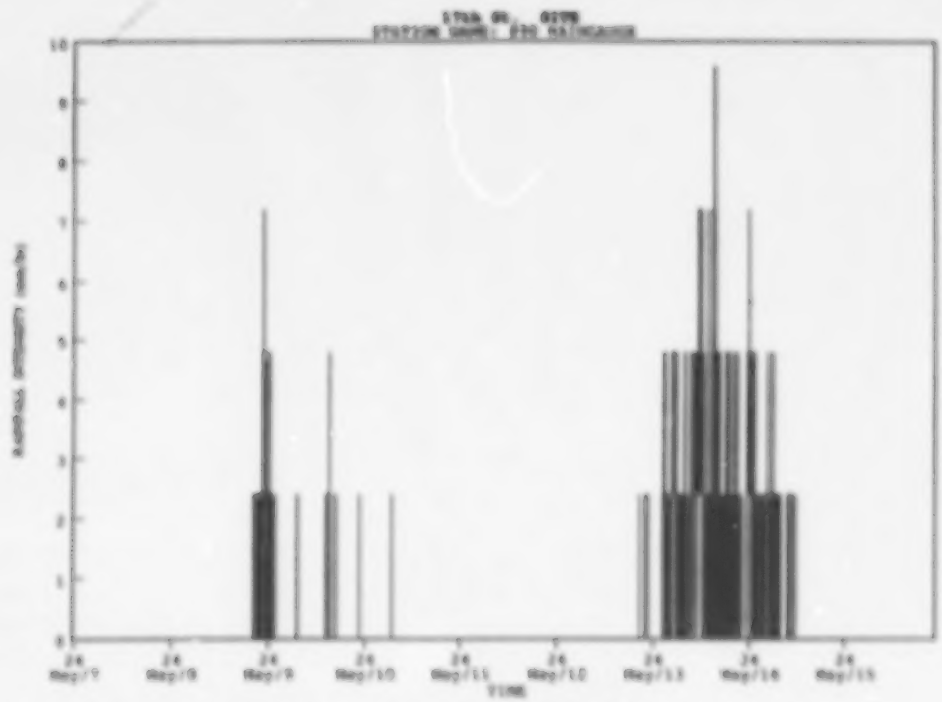
Figure 18 RAINFALL INTENSITY

May 14, 1991 The sump pump failed during an average intensity rainfall event, Figures 18 and 19. The failure resulted in a flooded basement. The time of pump failure was unknown and was discovered on May 15. Site grading at the time was poor with noticeable backfill settlement around the foundation. Also, the sump discharge was at the foundation wall. It is estimated that there was 7 m^3 of water in the basement. The sump pump system failure was attributed to a drain rock, from the sump base, caught in the impeller. Pump failure caused by a rock in the impeller, occurred again on both September 6 and 7, 1991. These pump failures occurred during the field testing program for sump pump systems.

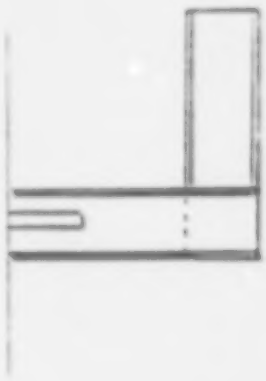
9. TYPE OF DISCHARGE STRUCTURE; DIAGRAM:

- 90mm DISCHARGE PIPE BURIED
- 90mm CLAY PIPE OF UNKNOWN
- DISCHARGE INTO CENTRAL DRAIN
- TRAP

DISCHARGE	
DRY	
LOW	
MEDIUM	
HIGH	X

- EXTREME DAMAGE TO YARD → VERY MUDDY AND WET IN WARMER MONTHS
- EXCESSIVE ICE BUILDUP

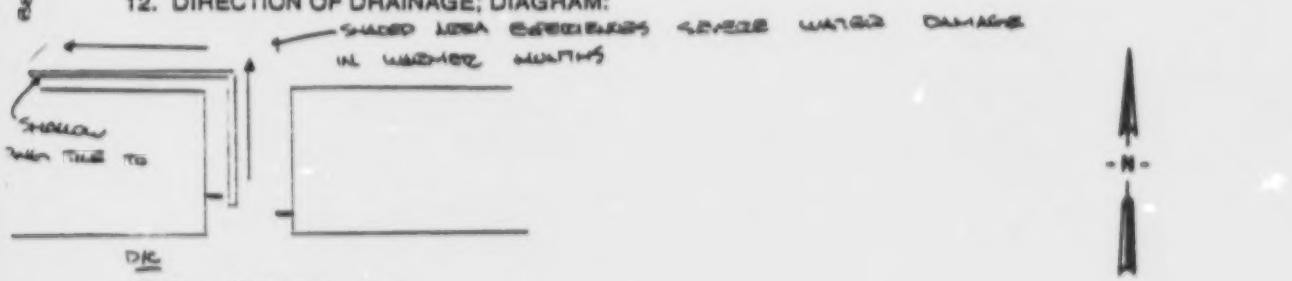
12. DIRECTION OF DRAINAGE; DIAGRAM:

DIC

DEV = 2 X PER HOUR
